**PROSPECT
PROPERTIES**
Home Inspections

Inspection Report For:

Property Inspected:
711 Byrd Park Court
Richmond, VA 23220

Date Inspected: April 25, 2011

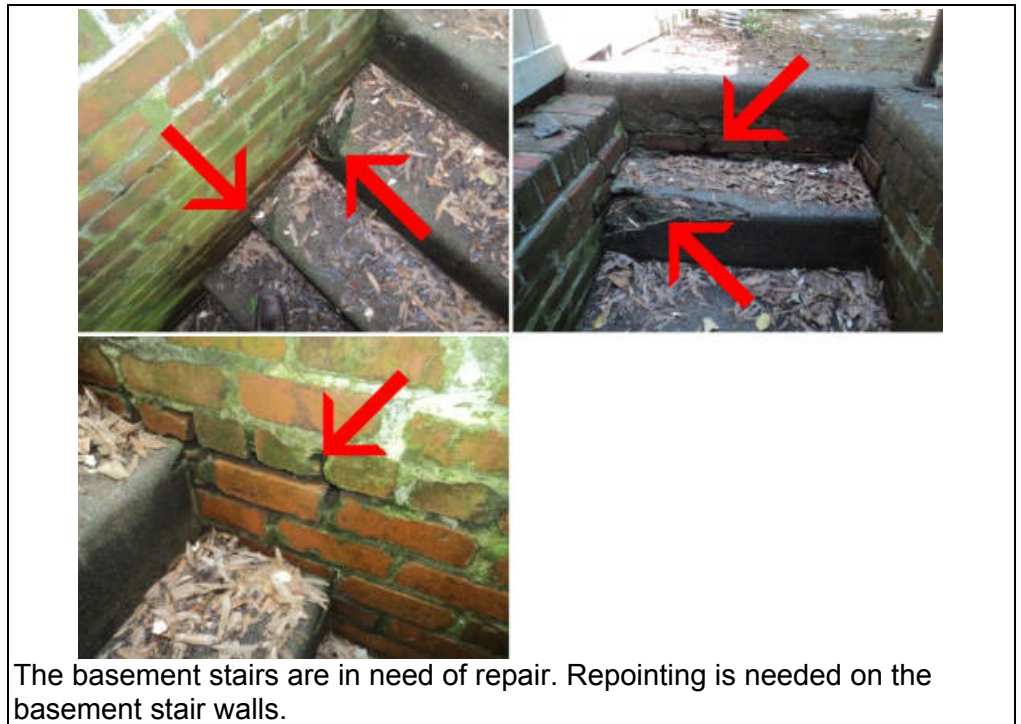
The basement stairs are in need of repair. Repointing is needed on the basement stair walls. **\$350 - 500.**

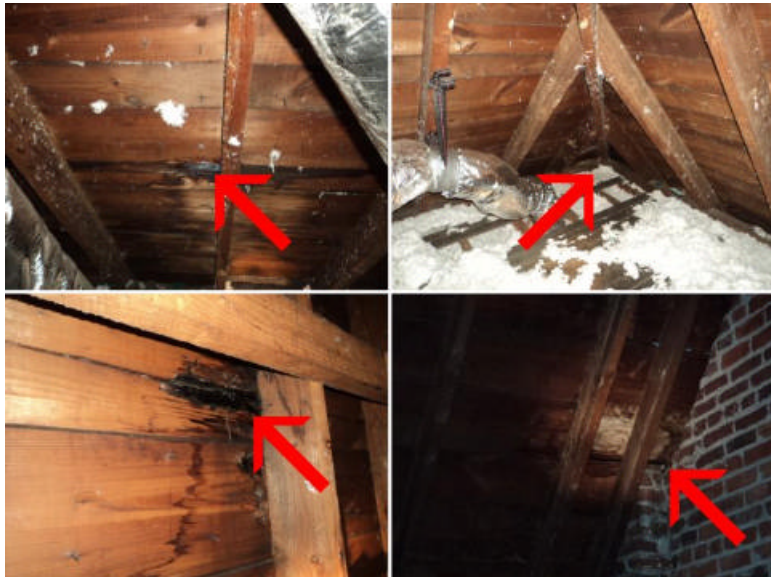
ATTIC CONDITION :

There are multiple areas throughout the attic that have stains. The accessible stains were tested with a moisture meter and are dry at this time. Daylight seen at some of the soffit areas.

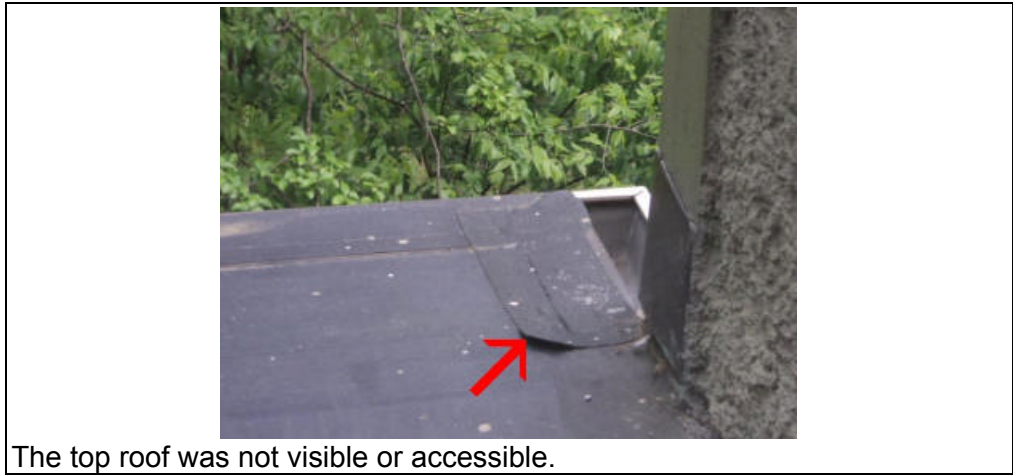
ROOF ACCESS:

The top roof was not visible or accessible.

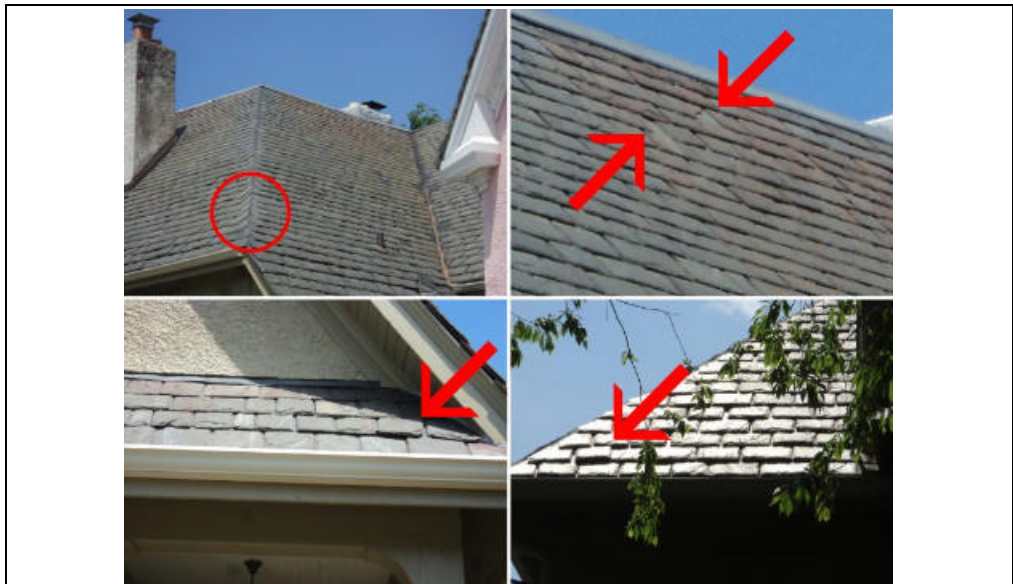
ROOF COVERING STATUS:

Some of the ridges need to be sealed. There are a few damaged and loose slates visible. There is a loose flap on the flat roof over the rear porch.

ROOF SYSTEM **Recommend having roofer further evaluate and price repairs.**

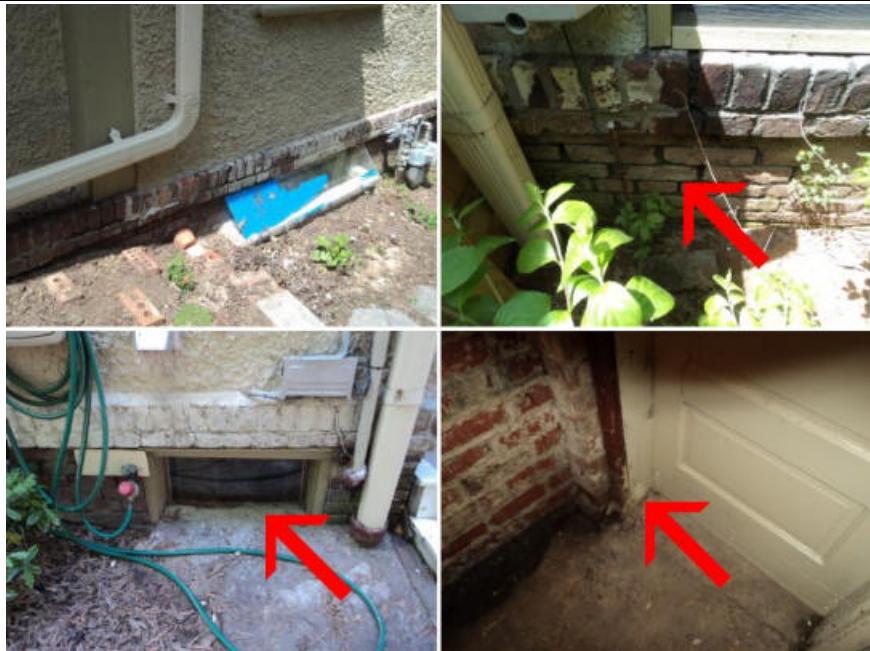
EXTERIOR CONDITION:

Evidence of past repairs to the stucco and the masonry. Repointing is needed at the right side foundation between the home and the screen porch. Moisture damage observed at the door jambs on the basement door. Wood trim is weathered.

Repointing is needed at the right side foundation between the home and the screen porch. **\$250 - 300.**
Moisture damage observed at the door jambs on the basement door. **\$100 - 150.**

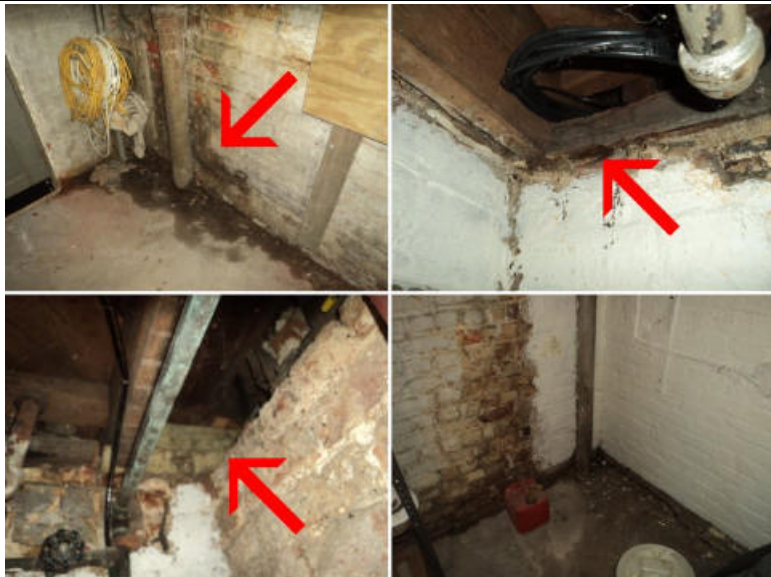
BASEMENT WALLS -
CONDITION:

Dehumidifiers are highly recommended for basement areas. Moisture damage observed at the right rear sill plate. Evidence of water seepage at the walls and slab. Consider consulting with a drainage specialist. Evidence of past repairs to the sill plate in the right front corner of the home. There is past insect damage to a floor joist above the basement toilet.

Moisture damage observed at the right rear sill plate. **\$250 - 350.** Evidence of water seepage at the walls and slab. Consider consulting with a drainage specialist. There is past insect damage to a floor joist above the basement toilet. **Estimated cost to sister floor joist, \$200 - 250.**

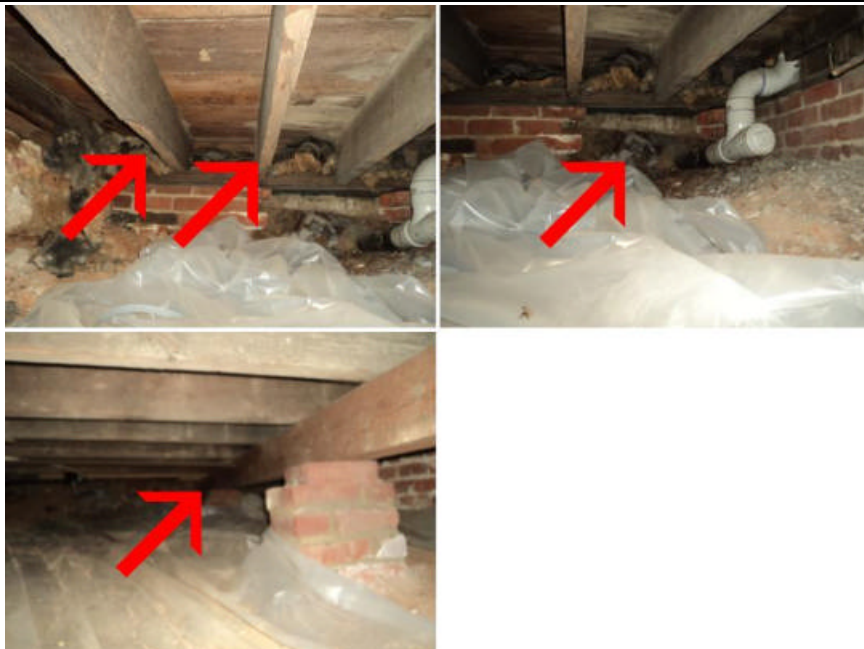
CONDITION:

Evidence of past insect damage to the joists under the front foyer. Recommend sistering these joists. There is a large opening in the front foundation wall under the front door. Evidence of past repairs to the floor joists under the living room.

Evidence of past insect damage to the joists under the front foyer. Recommend sistering these joists. **\$400 - 500.**

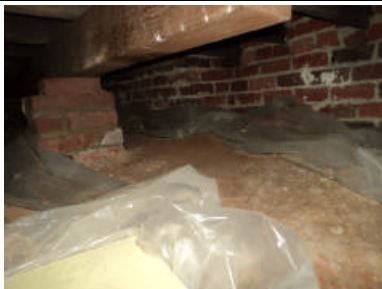
VAPOR BARRIER:

Vapor barrier needs to be straightened out.

Vapor barrier needs to be straightened out. **\$50 - 75.**

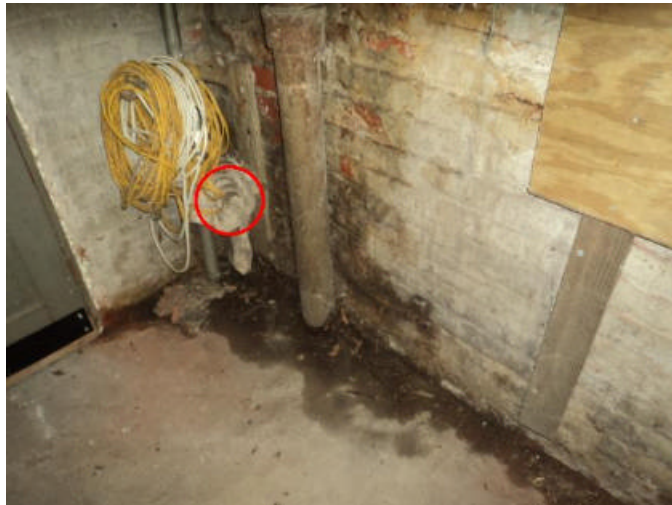
CONDITION OF SINK:

The old sink drain is not properly capped off.

The old sink drain is not properly capped off. **\$25 - 50.**

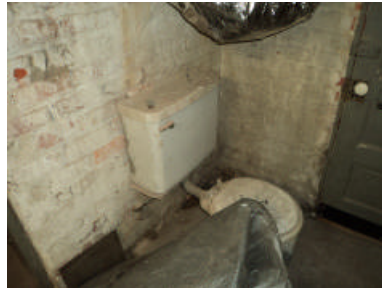
CONDITION OF TOILET:

The toilet is no longer in use and should be capped off to prevent the trap from drying out.

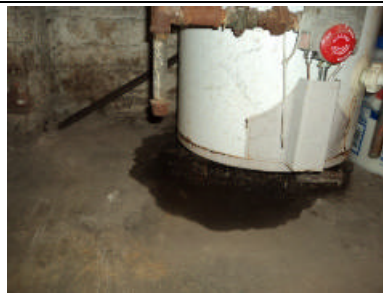
CONDITION:

Leakage has occurred. 2001.

Leakage has occurred. **Estimated cost to replace water heater, \$700 - 900.**

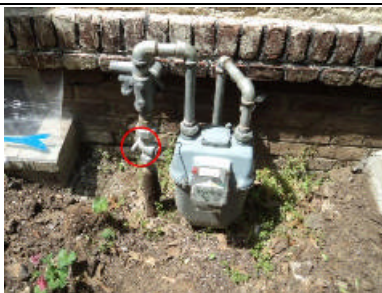
METER/TANK
LOCATION-CONDITION:

Meter located outside the house. Main cut off valve is at meter. There is an abandoned oil tank in the back basement room.

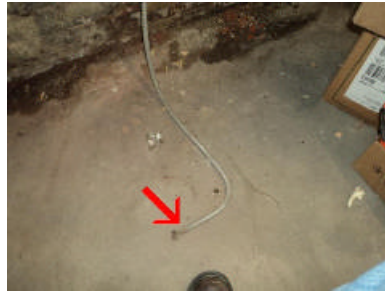
BRANCH WIRING:

Copper. Aluminum (220 volt OK). Wire is partially/largely hidden from view. Furnishing/Storage may prevent view of improper exposed wiring. Apparently active older "knob and tube"/cloth-covered wiring noted. This system is still commonly found but is old and will eventually need replacement. Some abandoned or disconnected wiring found in the basement.

Some abandoned or disconnected wiring found in the basement. **\$50 - 75.**
